PASTE BULKHEAD FAILURES

ABSTRACT: Bulkhead failures represent one of the greatest risks of any minefill operation. This paper details five bulkhead failures that have occurred at two different Australian paste filling operations over the past three years. The bulkhead design techniques are outlined, as are specific details of the failures, analysis of the failures and discussion of the causes and finally the resulting changes in the design and filling strategies adopted.

The failures presented in this paper have occurred at two paste filling operations referred to as “Mine A” and “Mine B”.

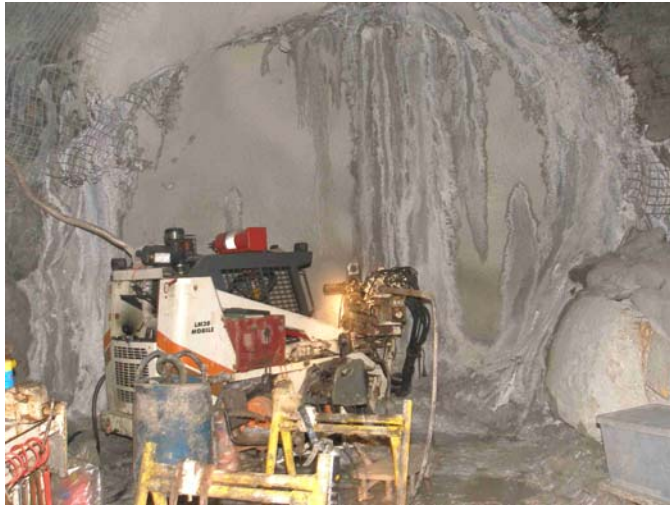
Mine A uses full sprayed fibrecrete bulkheads as shown in Figure 1. Figure 2 displays the geometry of a typical 5.0 m wide by 5.0 m high bulkhead. The fibrecrete is sprayed on a pre-fabricated steel frame. The frame does not form part of the barricade and simply provides a backing for spraying of the fibrecrete. No rockbolts or shear

Fig. 1. Fibrecrete bulkhead. Bobcat drill rig shown coring paste from behind the bulkhead.

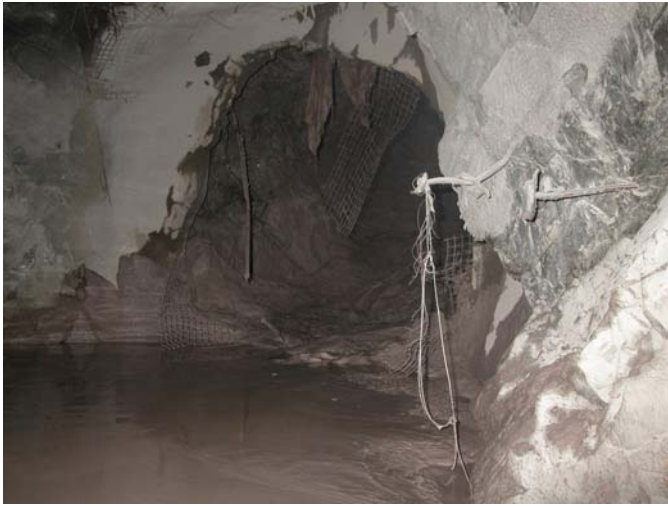
The stope being mined was experiencing significant fall-off on one of the side walls. The increasing rate of fall-off prompted the decision to cease remote loading and commence paste filling. As the fill level in the stope reached the 10 metre limit in the first 24 hours, the bulkhead failed, resulting in approximately 500 m³ of uncured fill flowing into the level (see Figure 4). No personnel were injured due to the failure. Investigations indicated that the failure resulted from the load imposed by 300 tonnes of rock falling off into the uncured paste fill.

Fig. 4. Photograph of bulkhead failure 1.

- Original mining sequence and development designs resulted in falloff along one of the stope walls.
- Increasing rate of falloff prompted decision to start filling as quickly as possible.
- An unstable rill of material was left behind within the stope.
- Due to both the rill left behind in the stope and the stope footprint the 10 m height of fill was placed in less than 6 hours.
- The key item was that the bulkheads, filling strategies and procedures were based on static loading. The risk of dynamic loading had not been identified in the planning and operational stages of this particular stope or any stope at the mine.

The major step implemented was the introduction of fill exclusion zones behind the bulkheads. Mullock bunds and “No Entry” signs were placed a nominal distance back from the bulkhead. The aim is that the bunds would contain and reduce the energy of

any failure events and it eliminates any personnel exposure directly at the bulkhead during the highest risk time, i.e. when the fill level is going past the bulkhead. No specific distance for placing the bunds back from the bulkhead was specified but rather the drive geometry is used where possible to place the bund around corners etc so that the energy of any fill failure is reduced before hitting the bund.

- The failure occurred whilst a primary/secondary stoping sequence was in place. The mine had already planned to change to a pillarless retreat method to assist in controlling mining induced stresses.
- An arch (radius of curvature of 6.5 m) was added to the pre-fabricated steel frames. Figure 5 below illustrates the increase in ultimate load of the arched bulkhead relative to a flat bulkhead.
- Risk of falloff was added as a checklist item in the paste fill note.
- Fill manuals were updated to include detail of failure so that future personnel are trained on the potential for dynamic loading.

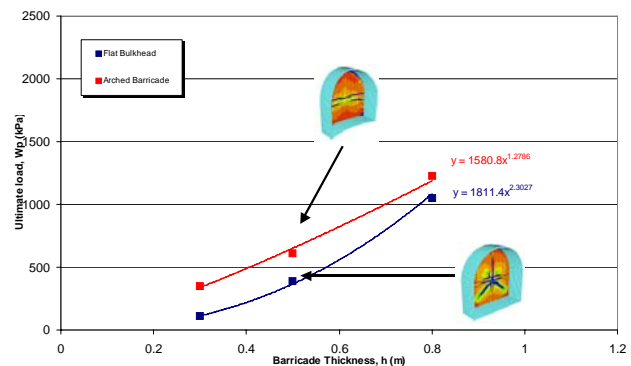
Fig. 5. Ultimate load for Mine A barricades after 1 day fibrecrete curing.

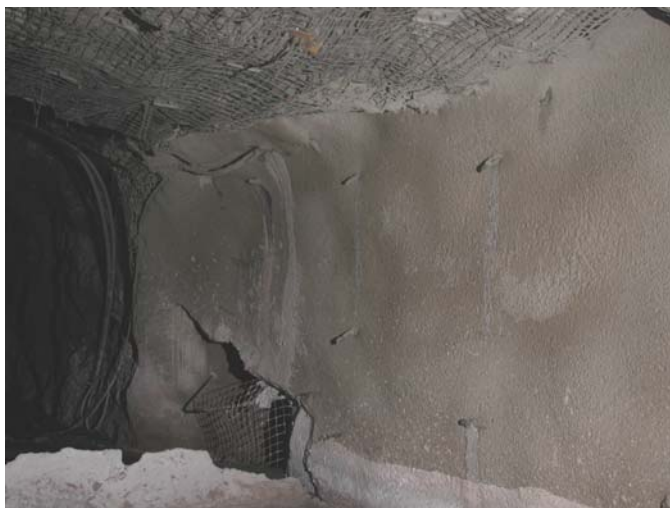
Failures 2 and 3 were similar to Failure 1 in that the paste plug had been poured and was being allowed to cure. Fall-off from within the stope is then understood to have created dynamic loading on the bulkhead causing partial failure as shown in Figures 6 and 7.

Fig. 7. Photograph of bulkhead Failure 3.

- As with Failure 1 fall-off is believed to have created dynamic loading on the bulkhead.
- Both bulkheads were significantly wider (8 m) than standard bulkheads.
- Both bulkheads were positioned on the footwall drive/x-cut intersection.
- Both failures occurred along the bulkhead-wall rock interface.
- It should be highlighted that the bunding and “No Entry Signs” had been appropriately placed on the level and prevented any personnel from being exposed to the hazard and limited the area affected by the paste spill.

- If initial investigations indicate the bulkhead must be built near an intersection, the location must be checked by the paste fill supervisor who will assess whether the bulkhead can be placed greater than 1 m from the intersection giving due consideration to exposing personnel to other hazards.
- When a bulkhead has to be built within 1 m of an intersection it should have rock bolts inserted into the rock wall to provide additional shear resistance.

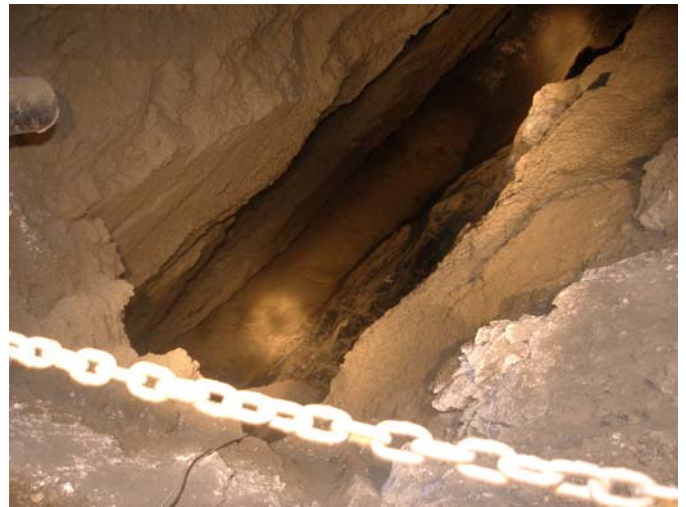
Mine B, uses an uphole bench stoping method to extract the narrow vein orebody. The ore is typically 0.5 m thick and dips at around 60°. The operation uses paste backfill as a passive support element and the paste is exposed vertically and horizontally simultaneously. Figure 8 shows a stope ready to be filled. The top of the paste plug covering the bulkhead can be seen.

Fig. 8. Mine B stope ready to be filled.

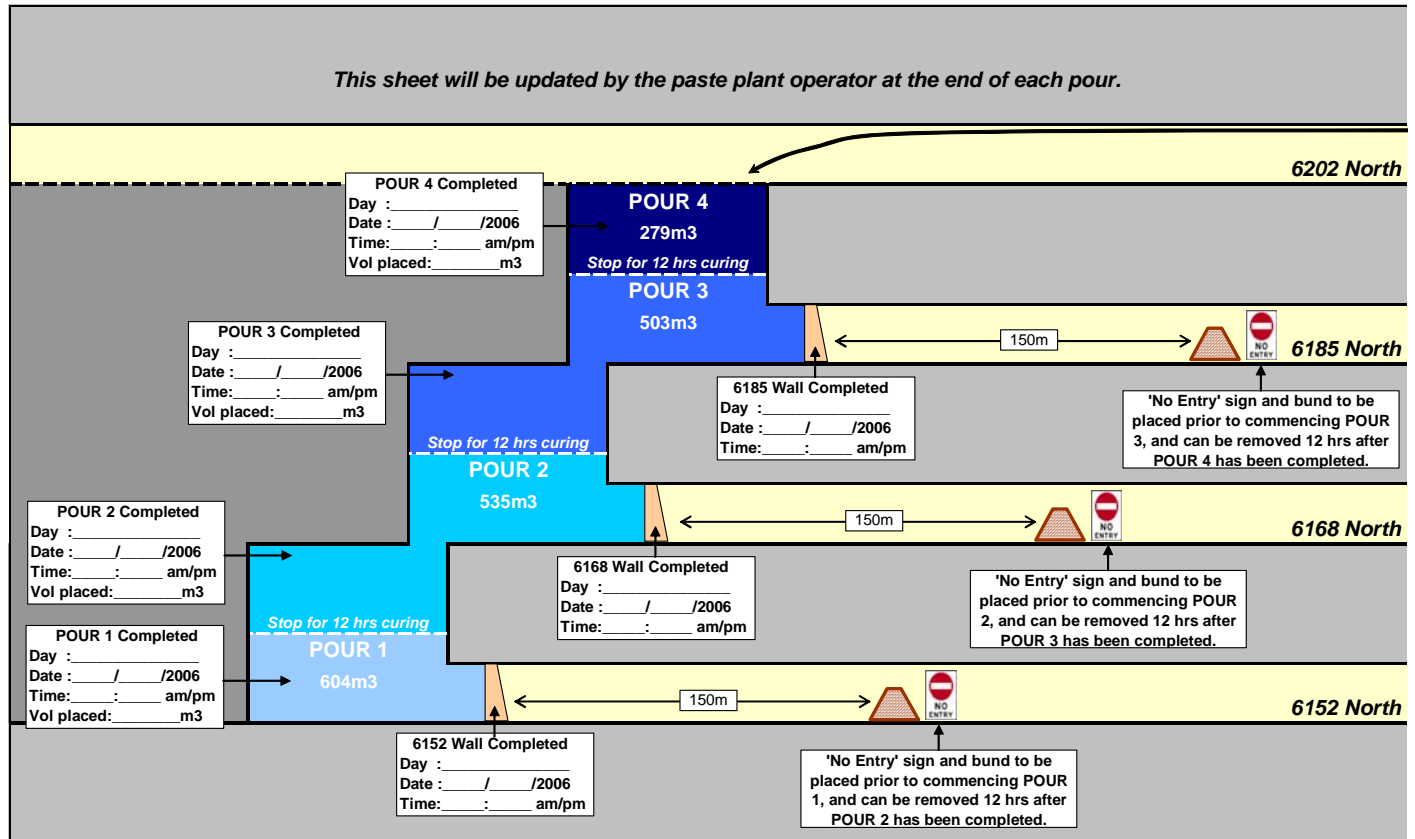
Figure 9 shows the details of a specific stope fill pour. It can be seen that each stope is composed of 3 panels. Paste is introduced at the top level only and cascades down the top two panels to fill the lower panel. No visual inspection is available of the filling of the lower panels, since the bulkheads are constructed prior to commencement of filling. Figure 9 also shows the detailed inspections required during the filling process. Some of these inspections were implemented following the bulkhead failures.

Fig. 9. Mine B stope filling sequence.

The bulkhead design is based on the filling method shown in Figure 9. Paste is poured to cover the bulkhead and allowed to cure for 12 hours before filling recommences. Using this filling strategy, numerical modeling and assessing a suitable Factor of Safety resulted in a design bulkhead load of 246 kPa.

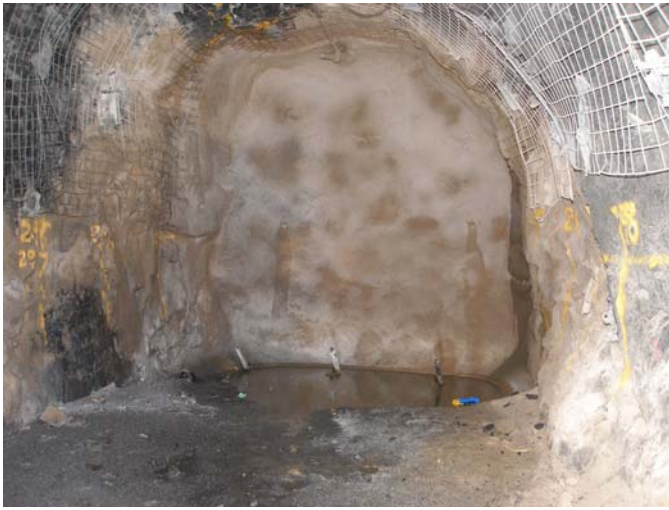
Initially Mine B used full sprayed Aquacrete bulkheads as shown in Figure 10. This was to be replaced with fibrecrete after approximately 6 months once fibrecrete was to be used in the development cycle. Aquacrete is a gypsum product that is provided in dry form in bulk bags. It is then combined with water at the spray nozzle and is applied in a similar way to fibrecrete. Figure 11 displays the geometry of the Mine B shanty back drive profile. The Aquacrete is sprayed on a pre-fabricated arched steel frame. The frame does not form part of the barricade and simply provides a backing for spraying of the Aquacrete. Initially no

holes were installed in the bulkheads although this was modified over time as discussed later in this paper. The Aquacrete was allowed to cure for 48 hours prior to commencement of filling.

Fig. 10. Aquacrete bulkhead.

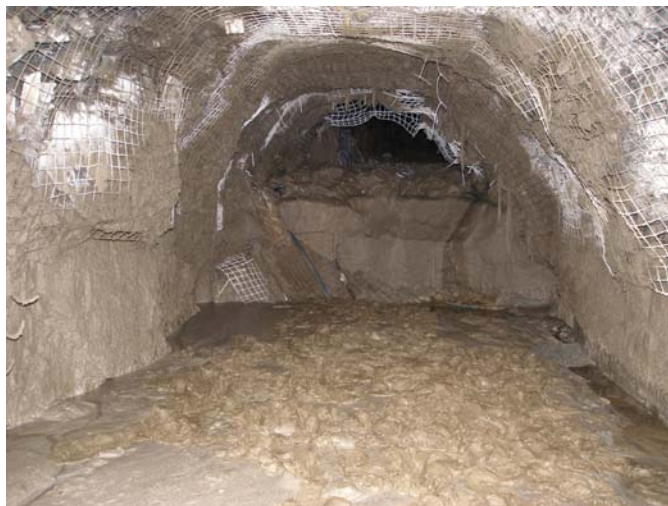
Figure 15 illustrates the bulkhead after failure. As observed, the Stage 1 (Pour 1) paste plug had not reached the required height of 6 m, leaving the top of the bulkhead exposed to the full hydraulic head created by Pour 2.

Fig. 15. Failure 2 incident scene.

- A volume of paste was retained on the upper levels. Whilst some volume had been allowed it is likely this was insufficient.
- Paste flowed 250 m down the ore drive from the bulkhead.
- Paste appeared to be of good quality and had commenced hydration (paste in ore drive could be walked on).
- No evidence existed of fall-off within the stope.
- Paste plug had cured well.
- Drive dimensions at the barricade location were 4.2 m wide and 4.4 m high. Due to the greater bulkhead dimensions the Aquacrete design thickness was 400 mm.
- The bulkhead note indicated the actual thickness sprayed was only 300 mm.
- Sections of the bulkhead recovered were 300 mm thick.
- Personnel positioned 150 m down the drive observed the paste flowing at a speed similar to a wave at the beach, and at a depth high enough to cover the wheels on their vehicle.

- The paste plug (Pour 1) did not reach a sufficient height to fully cover the bulkhead. As a result, the bulkhead was exposed to higher than design loading.
- The cause for the insufficient height was additional paste being held up on the upper levels compared to that predicted.

- Paste level monitoring systems were installed in the bulkheads. This consisted of conductivity probes that provide a signal back to behind the bund placed 150 m from the bulkhead.
- Polyethylene level pipes were installed in the bulkhead. These are inspected 12 hours after each bulkhead plug is poured. Filling only

recommences once it is confirmed that paste is above the bulkhead.
