Investigation of the geomechanical criteria for safe and efficient crown pillar extraction beneath stabilised rockfill at the Crusader Mine

Sainsbury, D.P.¹, Cai, Y.², Hebblewhite, B.K.²,
Finn, D.³, Whitford, J.⁴ and Berry, M.⁵.

¹Itasca Consulting Group, Inc.

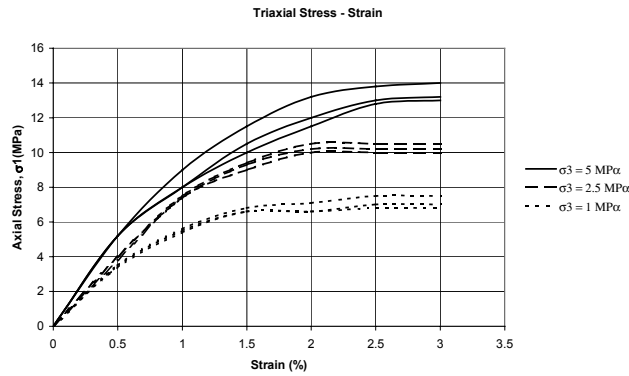
Figure 3 Unconsolidated drained triaxial stress-strain behaviour of stabilised rockfill.

The stress-strain behaviour observed in unconsolidated drained triaxial compression demonstrated that the stabilised rockfill material behaves as a Mohr-Coulomb material. Under a confining pressure of 1 MPa, strengths of 7 MPa were obtained. No post peak drop in axial stress was recorded, as displayed in Figure 3.

The laboratory measured cohesion and friction angle for the stabilised rockfill are 690 kPa and 44° respectively for a confining pressure between 0 – 1 MPa.

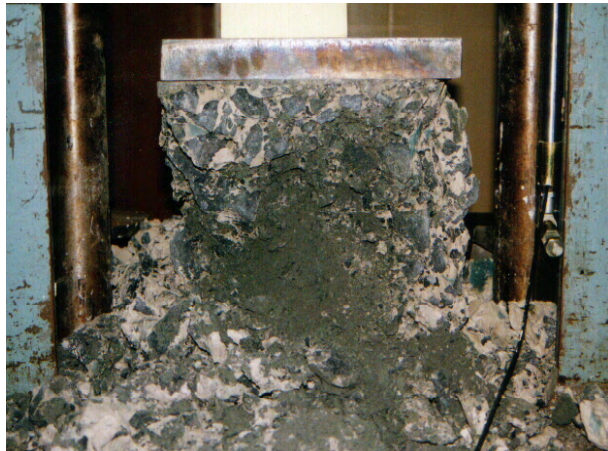
Figure 4 Large-scale laboratory unconfined compressive strength test.

Figure 4 illustrates a 300 mm cubic sample tested in uniaxial compression to 12% strain. As observed, the interlocking particles along the perimeter of the sample have been squeezed out towards the area of zero confinement, while interlocking particles in the centre of the sample have begun to grind together and rupture.

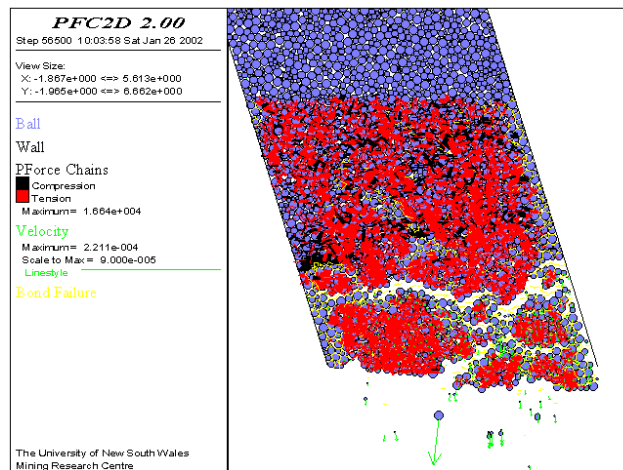
Figure 5 Predicted behaviour of 5m high artificial stabilised rockfill crown pillar.

The behaviour of a 5 m high artificial stabilised rockfill crown pillar is illustrated in Figure 5. As observed, progressive failure and caving is predicted along tensile failure planes in the de-stressed lower part of the stabilised rockfill, however, due to the inclined nature of the fill mass, compressive forces are able to arch over the upper part of the stabilised rockfill, impeding further yielding.

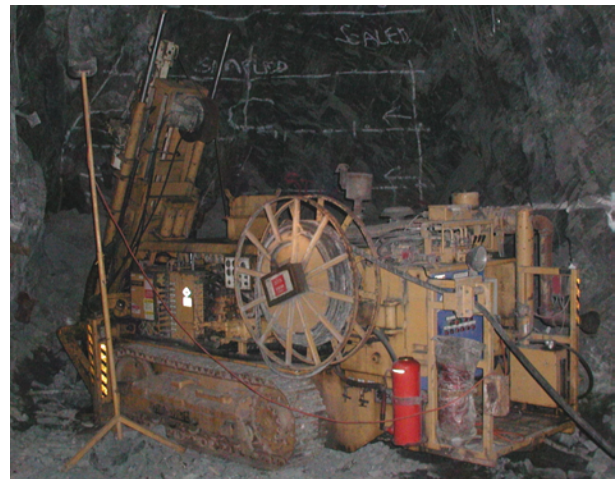
Figure 6. Cubex with Longyear 400 Series Feed Frame.

The concept of using a diamond drill to drill through loose rockfill underground is relatively untested. The primary difficulty with drilling through loose rockfill with existing diamond drill equipment is that the rig needs to be set up on top of the backfill, and therefore there is no means of anchoring the drill rig. MacMahon Underground Pty Ltd. were contacted and asked to devise a modified system to address this problem. The solution was to mount the Longyear 400 Series Drill Frame on a Cubex Megamatic 5200 Longhole Rig, this eliminated stability issues and also reduced set up time. The modified Cubex Rig is shown in Figure 6.

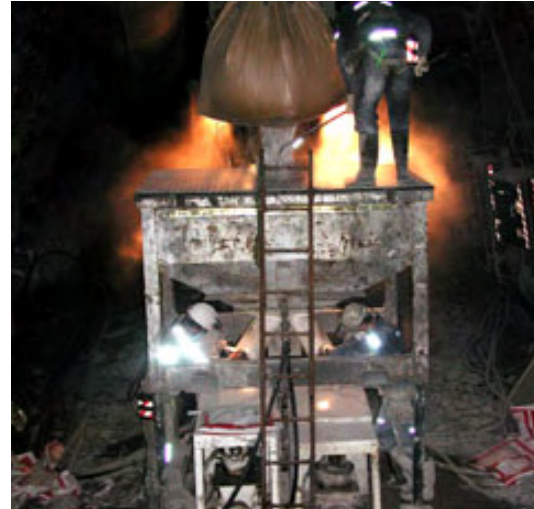
Figure 8. Cement Hooper and Pump Configuration.

Due to the large volumes of cement grout required, a 3 tonne capacity steel hopper was fabricated in order to facilitate the use of 1 tonne bulk cement bags to significantly reduce the labour required to deliver the cement to the mixing-pumping units. The hopper enabled the use of dual mixing-pumping units which effectively doubled the pumping capacity. Figure 8 displays the mixing and pumping process whereby a Cat IT 28 unit was used to transport the cement underground and position the bag above the hopper.

A pneumatically powered, and an electric powered placer pump unit were used to mix and pump the cement grout via 1 in. ID poly pipe to the previously inserted injection sleeves at a rate of approximately 3 t/hr (dry cement).

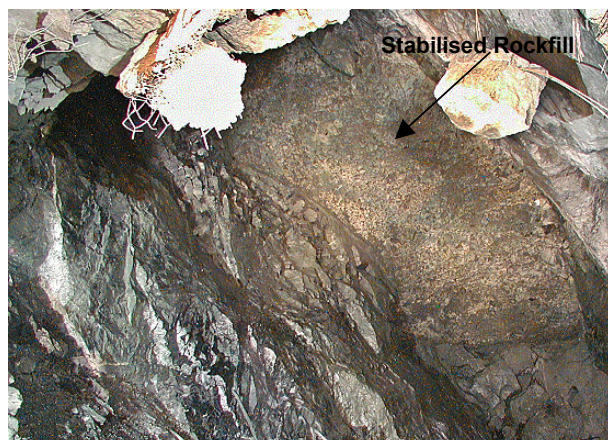
Figure 10: View from Beneath 955 Stabilised Rockfill Pillar.

The extraction of the 955 Crown Pillar was conducted progressively as a longhole retreat from the southern end of the pillar towards the 955 Level central access drive. Figure 10 displays the intact stabilised rockfill from beneath the brow of the crown pillar.
